# 1 Overview

The mechanical elements and services of the pixel detector are described in this section. We also describe the integration of the major components of the pixel detector and installation in ATLAS. The pixel detector, including the internal services, is located within the pixel support tube (PST) as already shown in Figure 2.1. A perspective view of the pixel detector elements within the PST is shown in Figure 1.

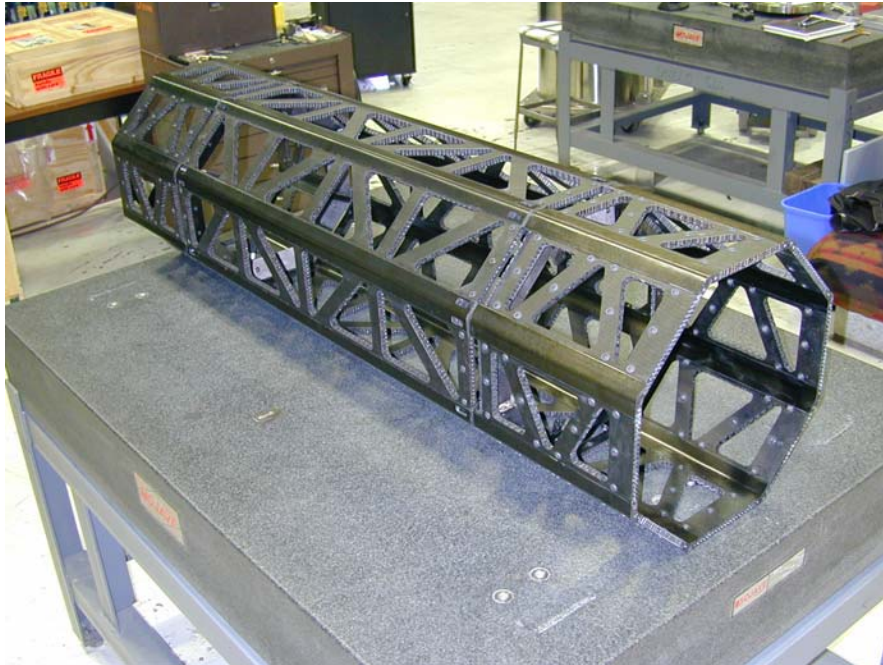
Figure 2: The support frame for the pixel detector.

The barrel shells and the disk rings are rigidly supported by a support frame constructed in three sections – a barrel section and two identical endcap sections. The support frame is constructed from carbon composites apart from small aluminum blocks in the regions where the barrel and endcap frame sections are bolted together. A picture of the support frame is shown in Figure 2. Four precision mounts are mounted on endplates attached to the support frame. These precision mounts engage mating supports in the PST when the support frame and the attached services slide through the PST during the installation procedure (section 7.7).

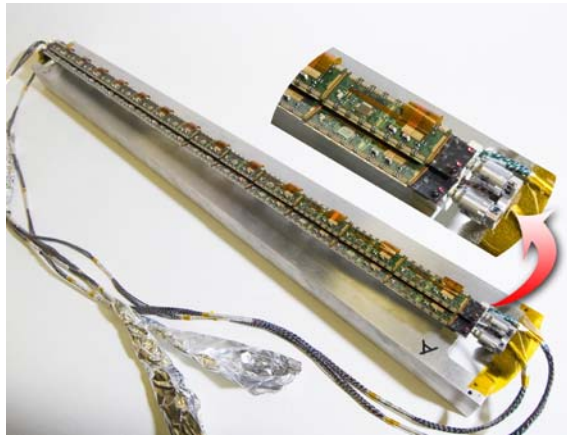
Figure 10: A bi-stave assembly.

Two staves (see Figure 10), each loaded with 13 pixel modules, were assembled together. Type 0 cables (section 8.5) were connected to the module and properly routed along the staves. Electrical testing was done during bi-stave assembly as was leak checking of the two cooling loops after connection of a U-link (section 8.5)

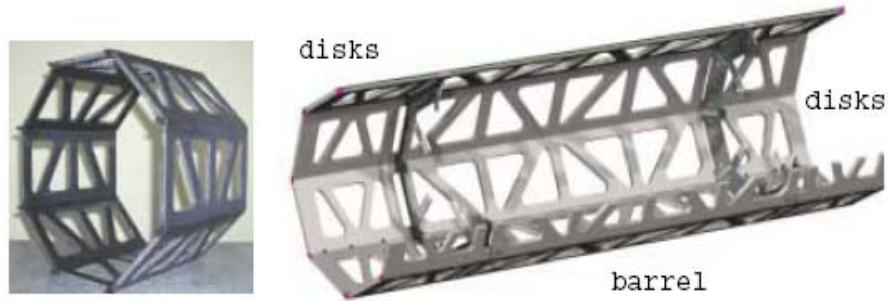
Figure 18: Carbon composite support frames.

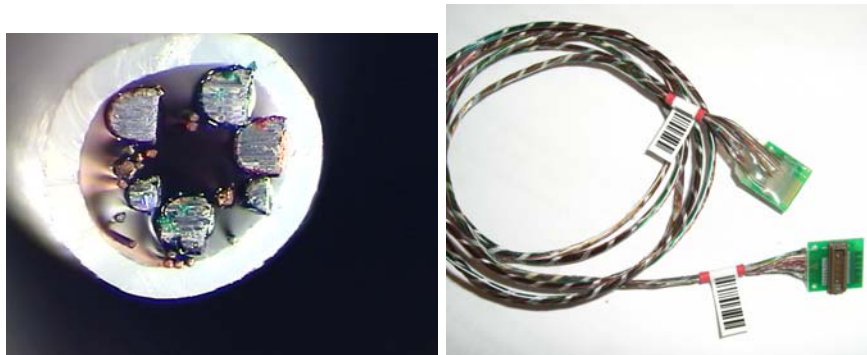
Figure 23: (a) Section through a disk T0 cable and (b) detail of a barrel T0 cable.

wire-bonded to the connector PCBs one-by-one. Figure 8.4.4b shows a detail of the ends of a barrel cable. The insulation stripping for the barrel cables was a high temperature chemical process and this caused some problems. The geometrical arrangement of the wires during the stripping operation could result in built-in stresses that led to mechanical failure of the conductor later on. This was not discovered until a full quantity of cables for the detector had been produced. For Layers 0 and 1, new cables were manufactured with geometrical control during stripping and improved quality control. For Layer 2 enough cables were accepted from the initial production following stricter quality control, including visual inspection of the individual wires before and after mechanical stress testing.

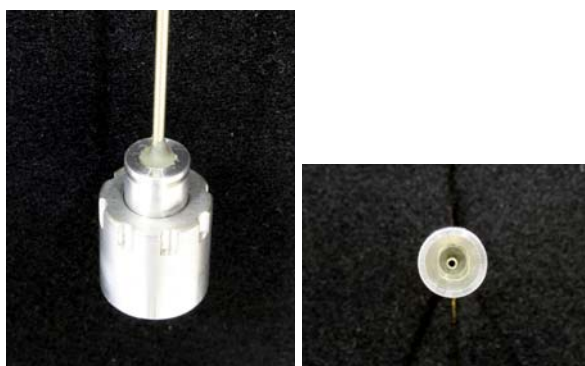
Figure 31: Capillary bonded to aluminum fitting. (a) View from the back of the fitting and (b) view from the front of the fitting.

The ends of the capillaries were adhesively bonded (footnote Hysol 9394) to aluminum fittings (described in more detailed below). A picture of a capillary bonded to a fitting is shown in Figure 8.4.12a and Figure 8.4.12b.

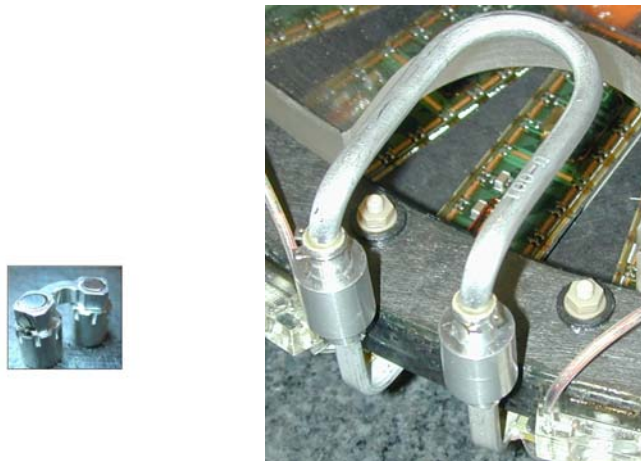
Figure 32: (a) U-link structure used to connect to staves to form a bi-stave unit and (b) U-tube for connecting disk sectors, during assembly of a disk.

Connections between two staves in the barrel region and two sectors in the disk region were made by U-links and U-tubes, respectively. A U-link is shown in Figure 8.4.13a. The design of the U-link is driven by tight space constraints at the ends of the staves. The U-link is a machined and bent small aluminum structure made with multiple e-beam and laser welds. A U-tube is a simple round tube bent into a U-shape to which the appropriate fittings are attached by laser welding (see Figure 8.4.13b).

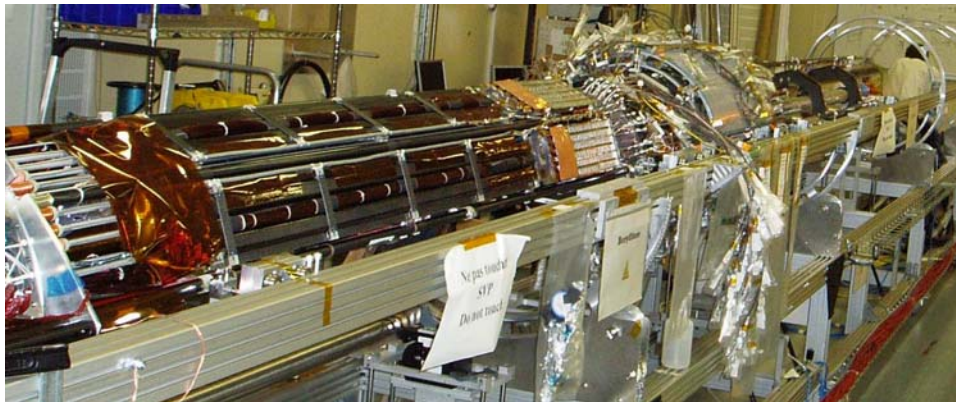
Figure 46: Pixel package is loaded with the first SQPs on the ITT.

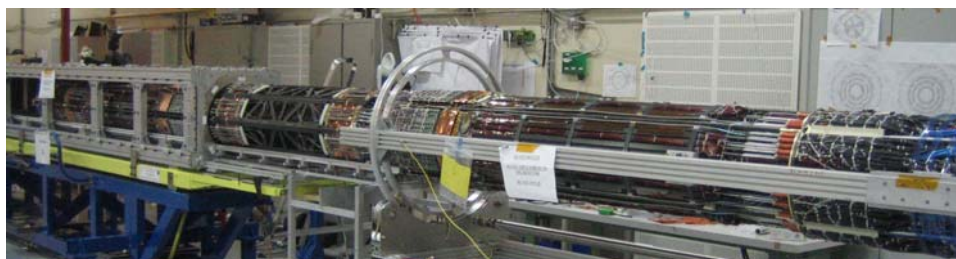
Figure 48: The pixel detector leaves the tool on which has been integrated (ITT on the right) and it enters into the transportation tool (DST on the left). The blue structure underneath the DST is equipped with pivoting and spring loaded wheels for an easy and shock free transfer outside the building.

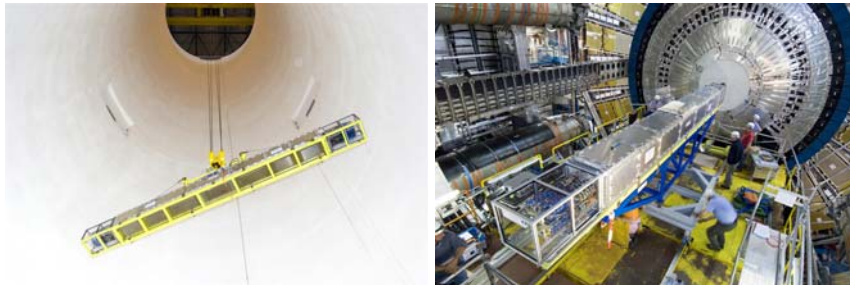
Figure 49: (a) the pixel detector in the Dummy Support Tube (see text) being lowered into the ATLAS underground hall and (b) the Dummy Support Tube and pixel detector on a platform between the Inner Detector area and the endcap calorimeter.
